A NEW VISION FOR VULCAN THE PLAN

Birmingham Historical Society

May 22 1999

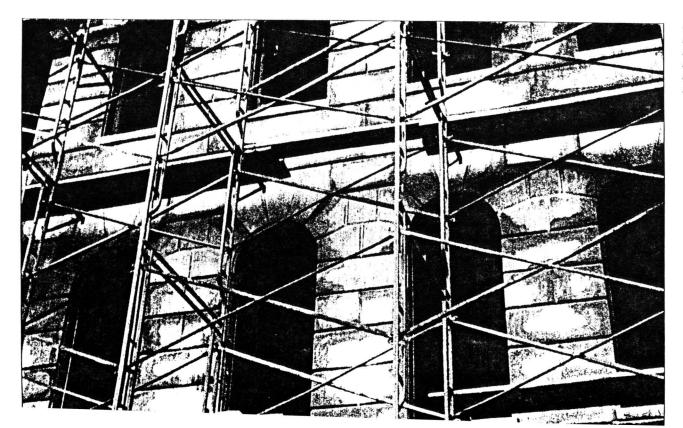
Composite patching with a cementitious mixture is being used to repair eroded areas of this sandstone facade.

Moisture from a faulty roof and drainage system has been trapped inside this limestone cornice by a waterproof coating, causing severe damage to the stone.

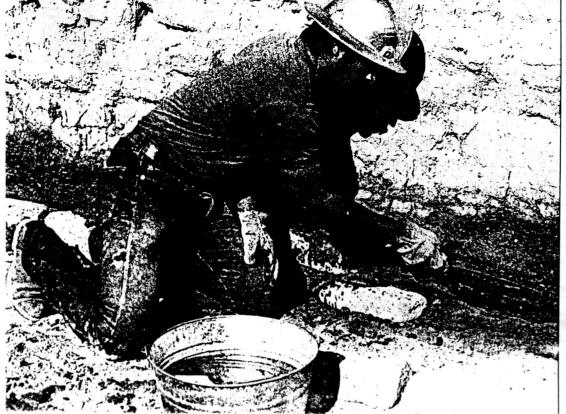
Coving—the bollowing out of an adobe wall just above grade—may be caused by standing rainwater, rainwater splash-up from the ground, or by salts deposited in the adobe by moisture evaporation. This adobe wall is being patched in the traditional manner with adobe mud.

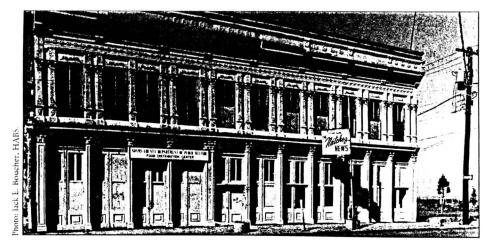
Deteriorated portions of the decorative pressed metal cornice have been inappropriately replaced with nonmatching, plain metal sheets, adversely affecting the historic character of this building.

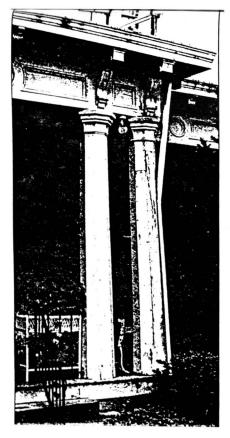
The roof drainage system has been neglected for such a long time that, as a result, the wood comice and a porch column are both severely deteriorated.

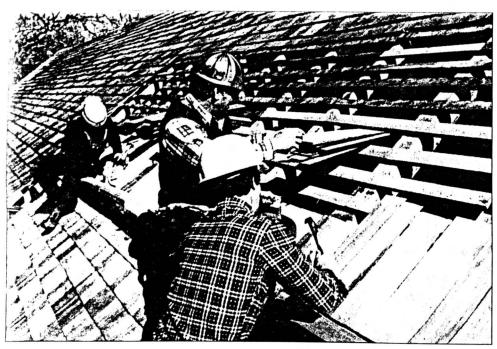
The size, shape, and detailing of the historic shingles as well as the method of fabrication and installation were carefully researched prior to selecting this new woodshingle roofing.

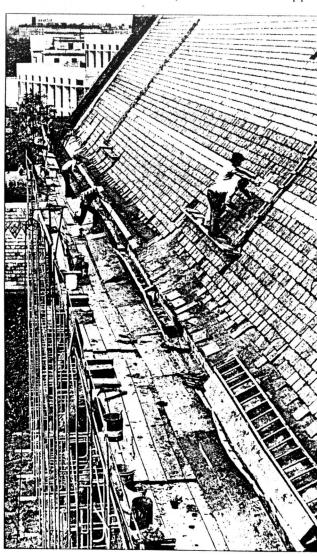
Workmen are in the process of removing deteriorated roofing slates and replacing them with new matching slates.

New galvanized sheet-iron shingles will need to be reproduced using the pattern of the original shingle.

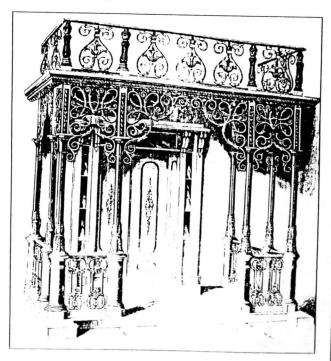
In the 19th century some cast-iron porches could be purchased by mail. such as this madeto-order veranda which was featured in an 1870 foundiv catalog.

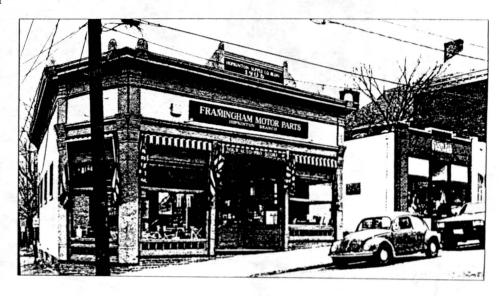
These architectural details are typical of historic commercial buildings (this particular one is No. 4016 in the George L. Mesker and Company catalog of 1905). The design utilized both east and galvanized iron.

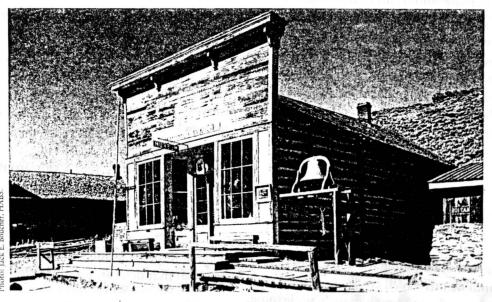
A false-fronted wood store is now used as a museum. Although the weathered wood is part of its charm, repainting is recommended as a good maintenance practice to protect the wood.

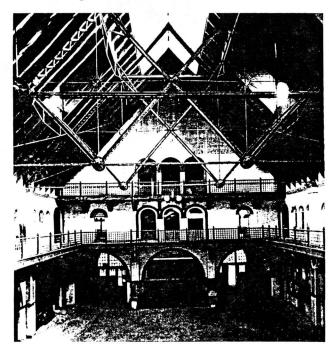
The exposed metal roof-truss system of this waiting room not only provides structural support, but is also important in defining the interior character of the train station.

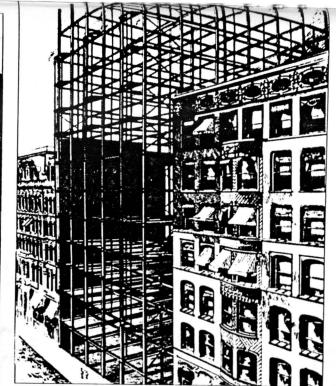
Unity Building, Chicago, Illinois, 1891-1892 (Clinton I. Warren, architect). The development of the skeleton frame was pioneered by architects of the "Chicago School" in the late-19th century. With this method the weight of the building is carried on the frame, not the walls, allowing the construction of taller buildings without increasing the wall thickness.

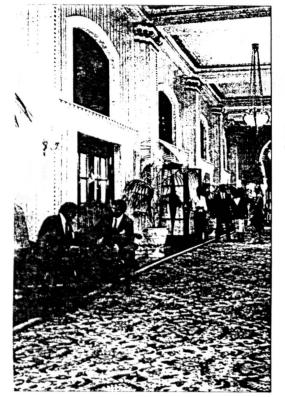
During rebabilitation, the historic plaster was removed from perimeter walls, leaving the brick exposed; in addition historically painted wood trim was stripped. Removing finishes not only destroys historic materials that should be retained and preserved, but it also gives the interior an appearance it never had historically.

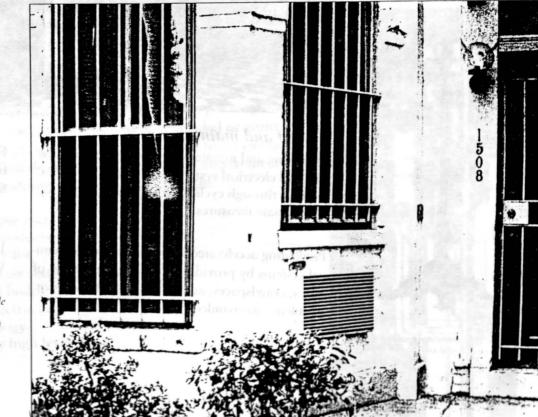
The historic window on a primary facade has been shortened and the area below it filled in with brick in order to install a through-the-wall air conditioning unit. In addition to changing the window size and destroying the sill, the unit itself is visually obtrusive.

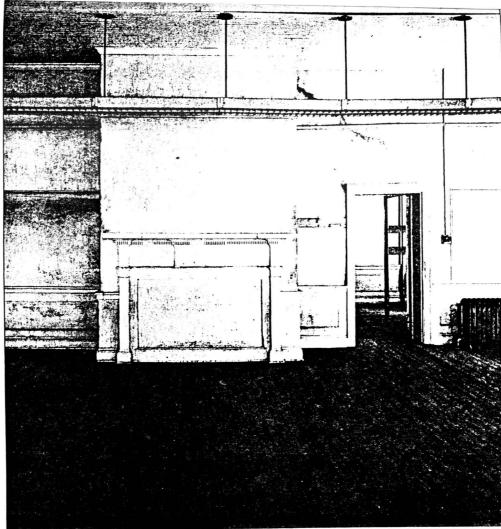
This row of hanging fluorescent lights installed in an earlier renovation mars an otherwise classically detailed interior. They have also caused the historic headed ceiling to pull away from the joists.

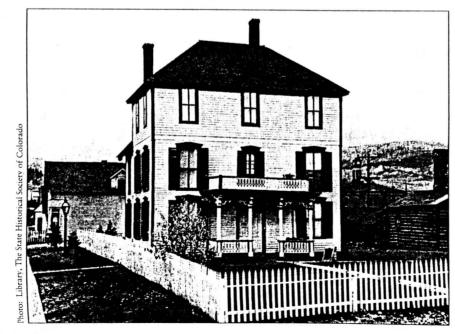
This wood picket fence is as important to the site as the shutters, porch detailing, and clapboards are to the house. As such, the fence was carefully repaired and painted as part of an overall project to preserve the historic residence.

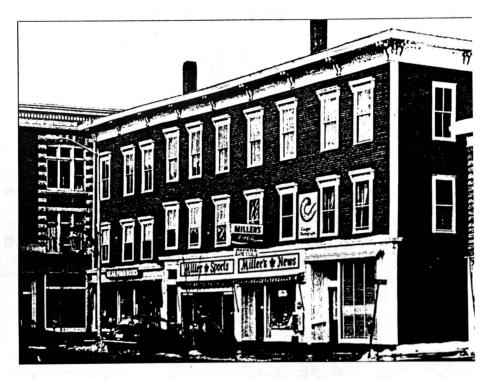
In an urban historic district, the alignment and width of roads, the relationship between buildings and yards, and the repetition of trees lining the streets help define its historic character.

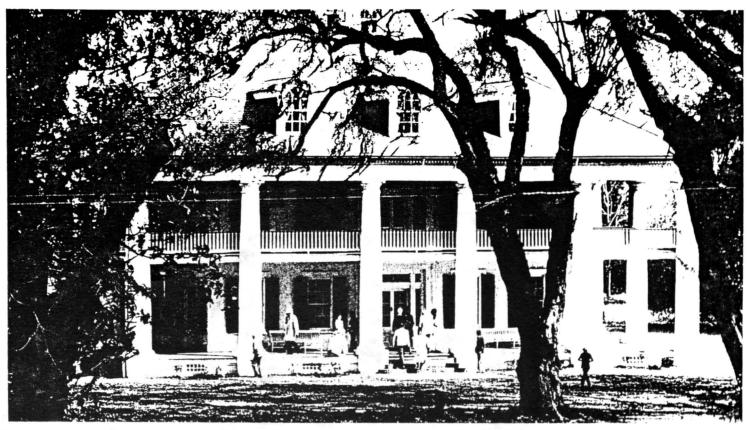
In hot climates, buildings were bistorically designed to minimize the heat gain from the summer sun. The wide roof overhangs, exterior porches, shutters, shade trees, and heavy masonry walls (painted white) are all energy saving characteristics.

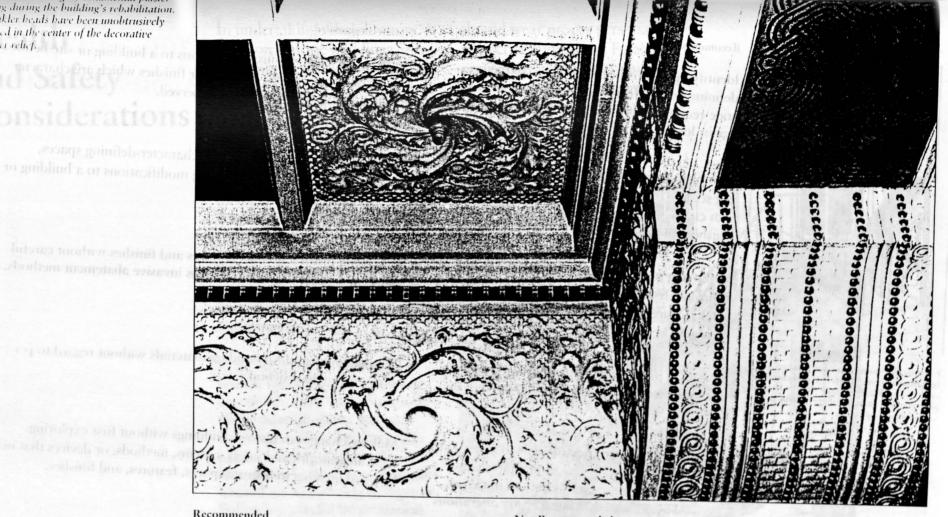
installed in this highly ornamental plaster ceiling during the building's rebabilitation. Sprinkler heads have been unobtrusively located in the center of the decorative plaster relief. The ter specification is of an
